CALSPAN ON-SITE INADVERTENT AIR BAG DEPLOYMENT INVESTIGATION

CALSPAN CASE NO. 92-8

VEHICLE - 1990 PLYMOUTH ACCLAIM

LOCATION - [REDACTED], GA

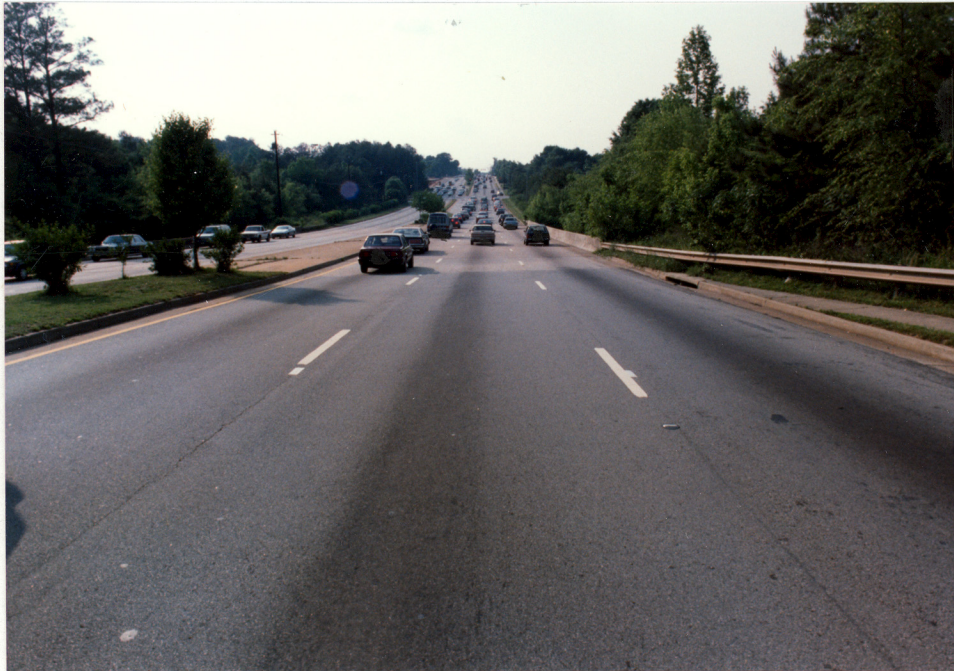
Path Of Travel Of The 1990 Plymouth Acclaim.

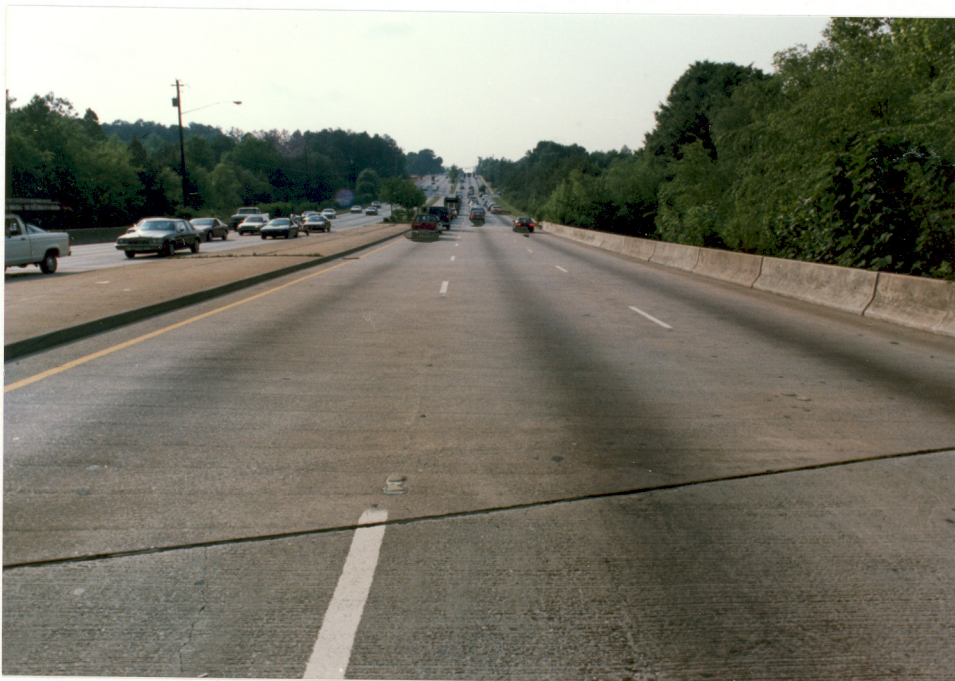
Vehicle's Continued Path Of Travel.

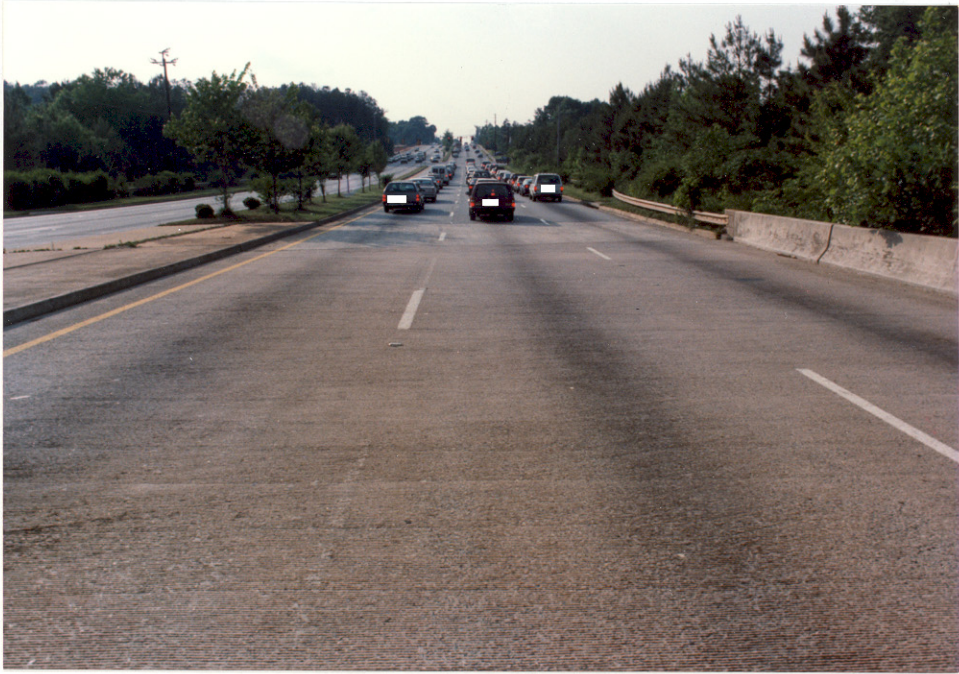
Vehicle's Trajectory To The Area Of The Alleged Inadvertent Deployment.

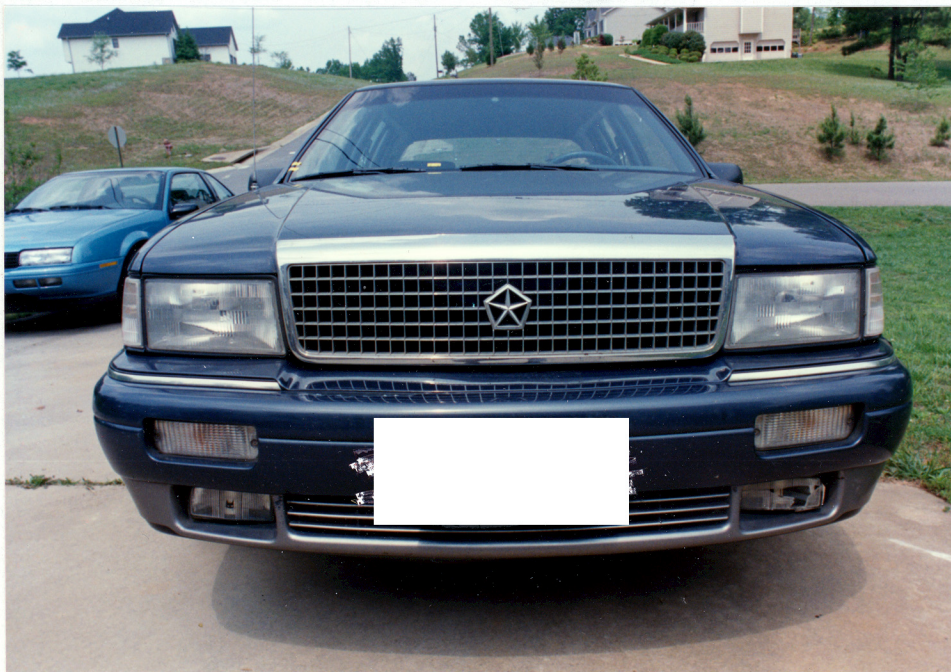
Frontal View Of The 1990 Plymouth Acclaim.

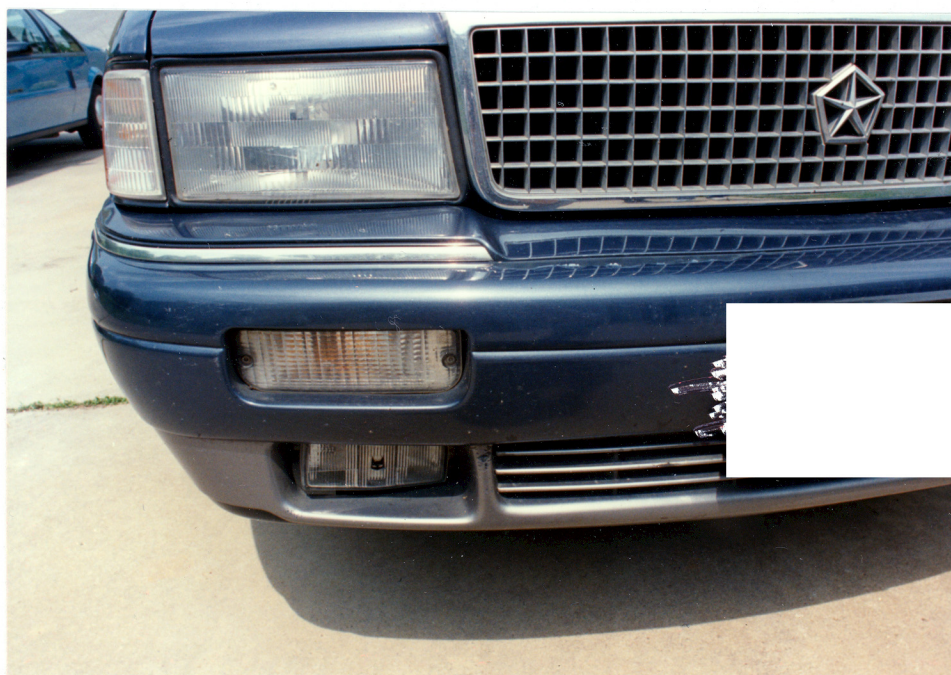
Closeup View Of The Right Front Bumper Facia.

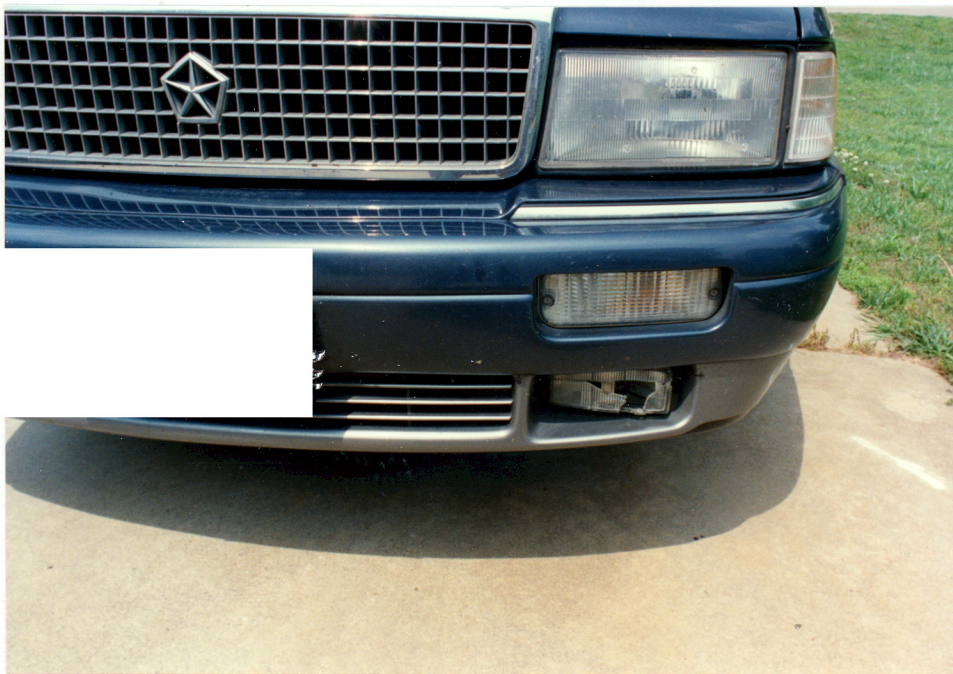
Closeup View Of The Left Front Bumper Facia.

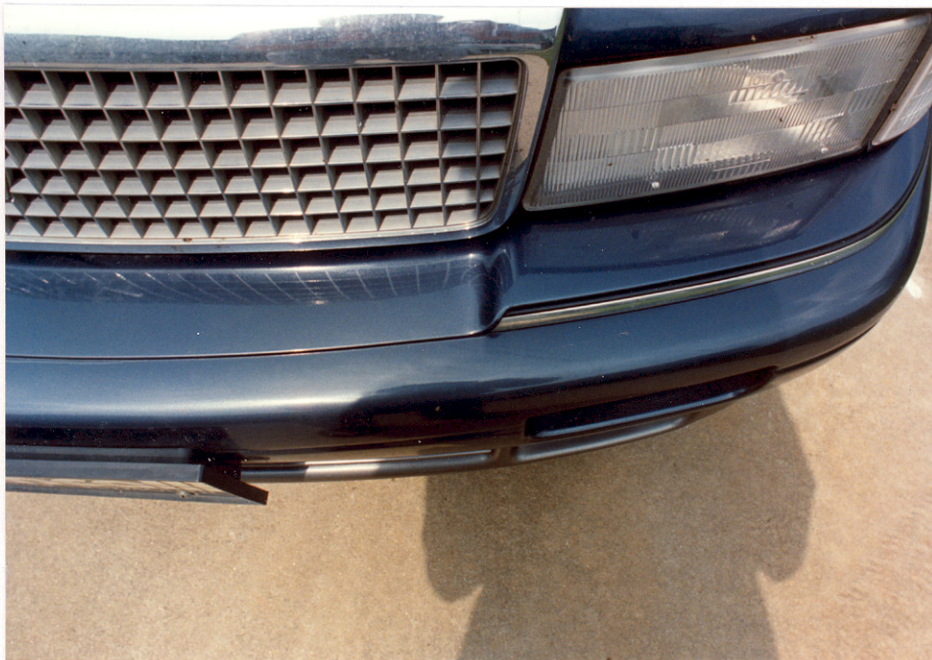
Top View Of The Left Front Bumper Facia.

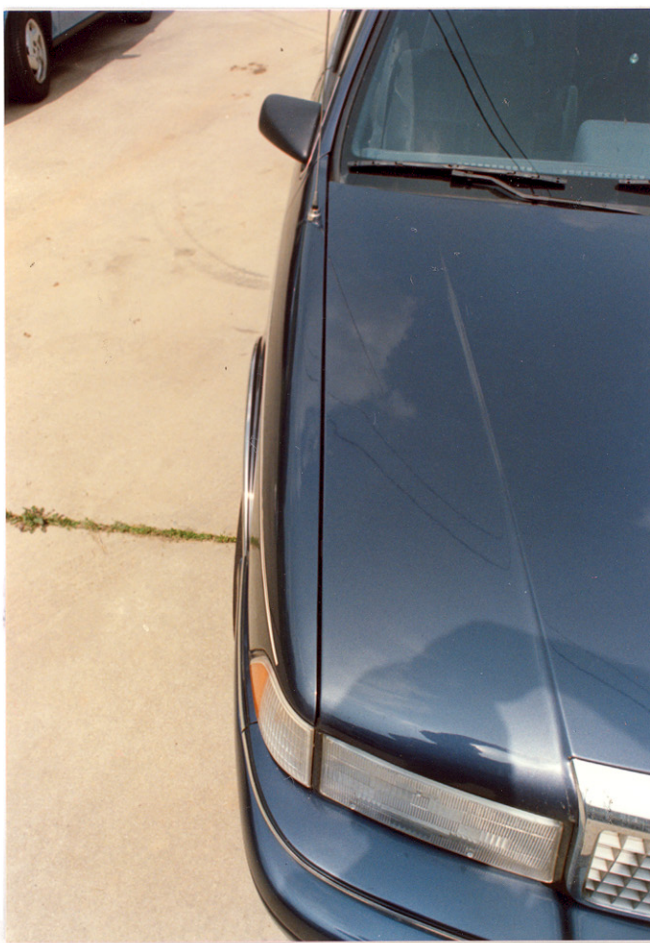
Longitudinal View Of The Right Hood Edge Fender Spacing.

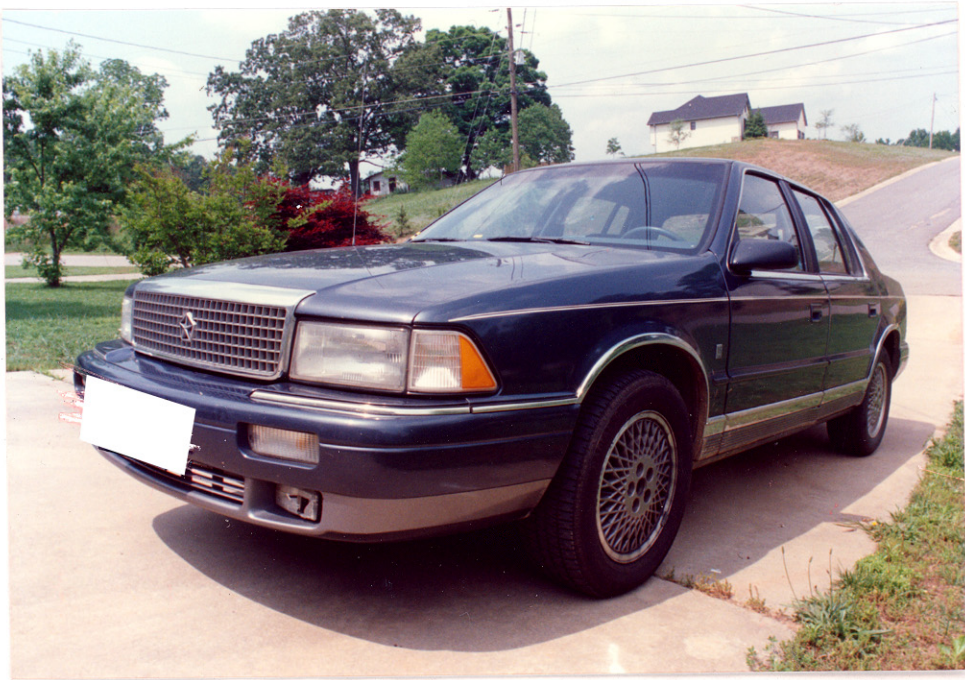
Left Front Three-Quarter View.

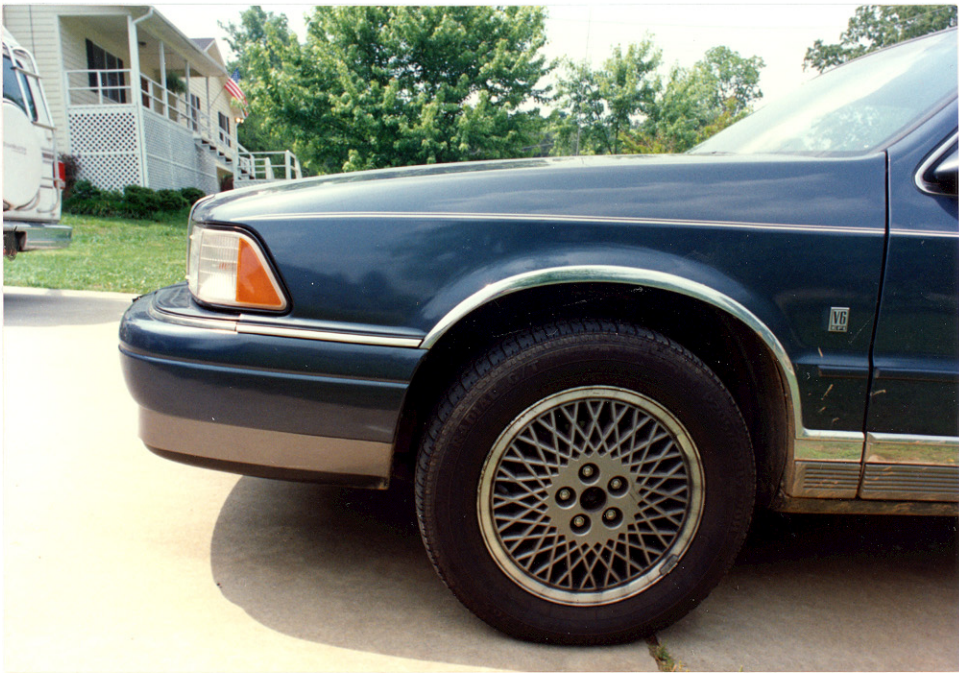
Perpendicular View Of The Left Front Fender.

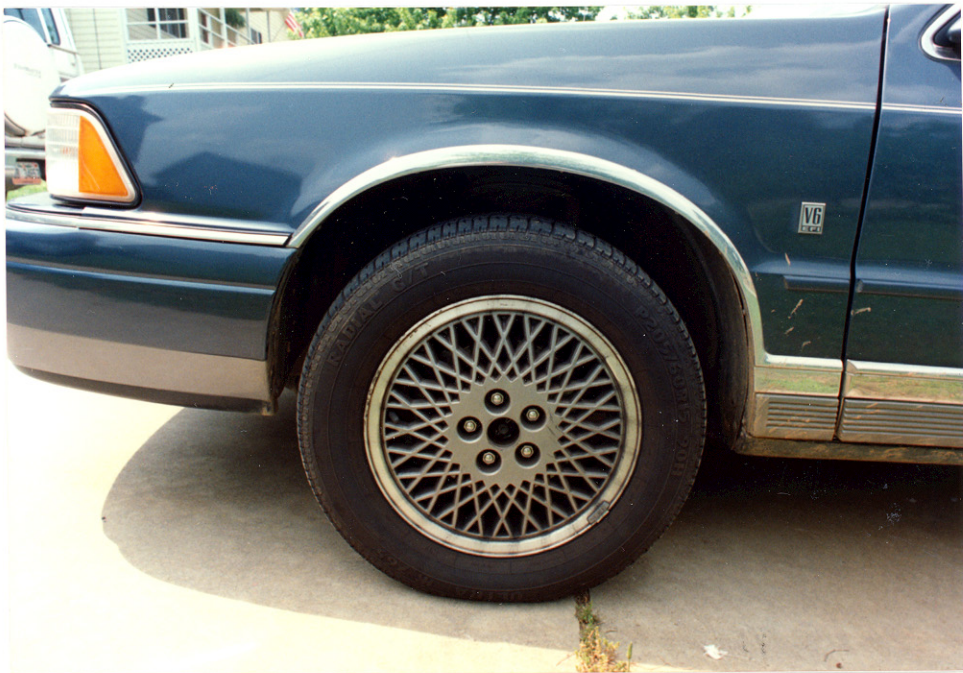
The dealership identified damage to the right front inner fender and to the right front alloy wheel. There was no visible damage to the inner fender area of the vehicle. The owner pointed to a tar-like transfer on the outer edge of the right front wheel which the dealer identified as damage. The transfer was superficial with no deformation or cracks to the alloy wheel. The center plastic dust caps were missing from the left front and right front wheels of the vehicle.

Left Front Wheel.

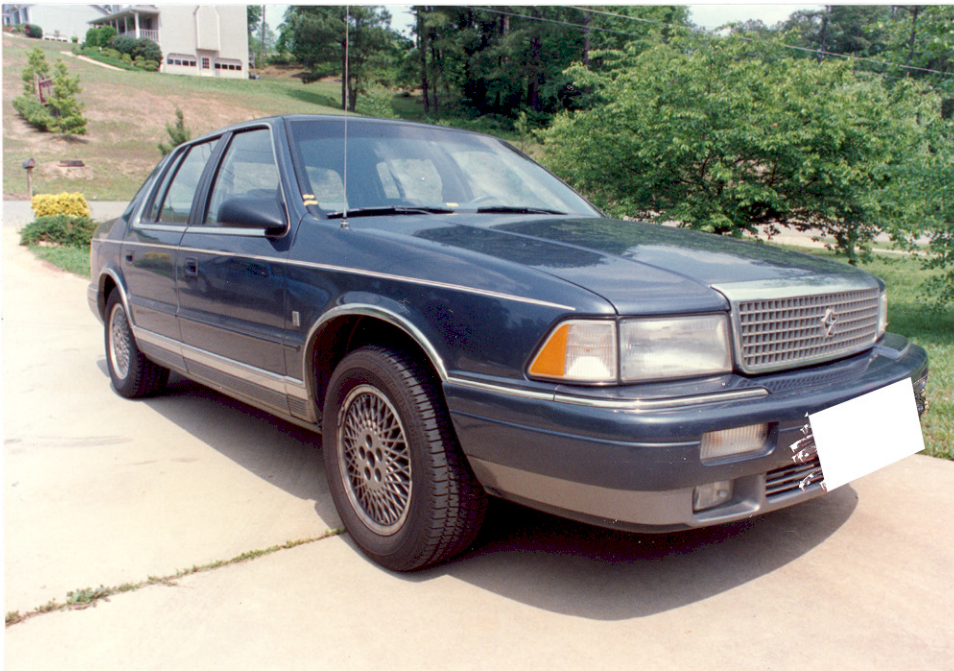
Right Front Three-Quarter View.

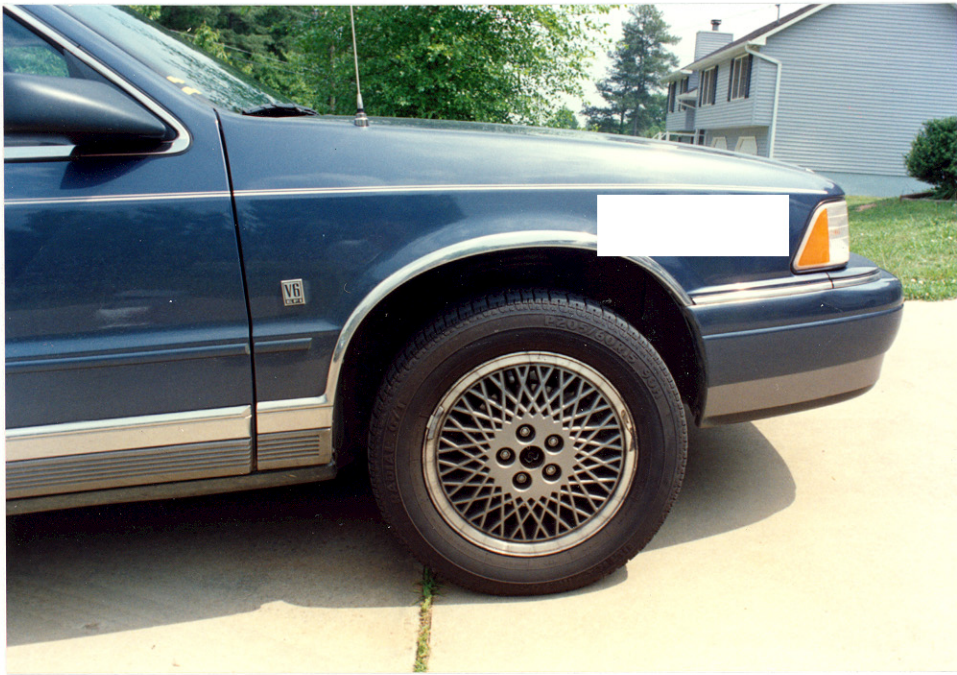
Perpendicular View Of The Right Front Fender.

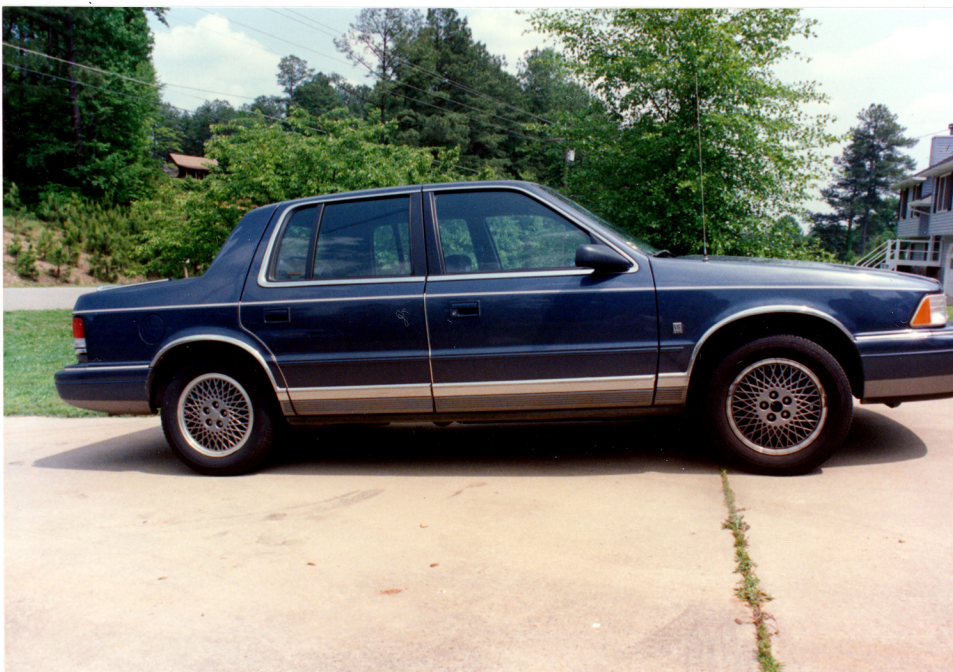
Overall Right Side View.

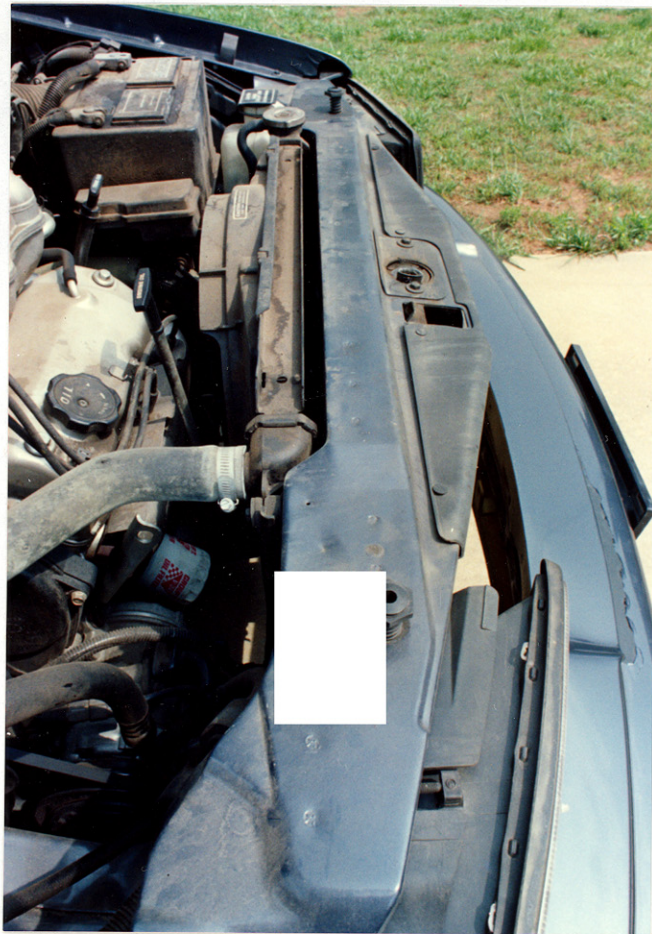
The radiator core support did not appear to be damaged as noted by the dealership during their inspection of the vehicle on [REDACTED] 1992. The upper edge of the core support was straight from fender to fender. The core support appeared to be properly aligned vertically on each side of the radiator. The air bag crash sensors were mounted to this section of the core support and both sensors were properly positioned both vertically and horizontally. There was no damage to the sensors or to the associated wiring or female connectors. The sensors were removed from the vehicle and shipped to NHTSA for additional inspection.

Perpendicular View Across The Upper Core Support.

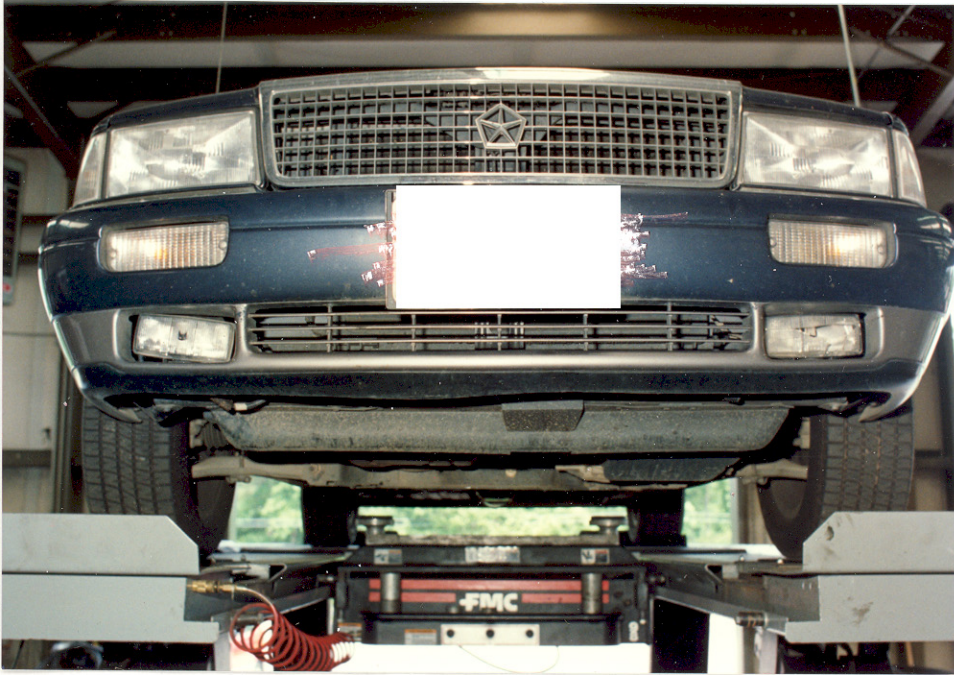
The front bumper fascia did not yield evidence of impact (i.e., scratches, paint transfers, gouges, cracked license plate frame, etc.). The paint at the lower portion of the fascia (painted gray) at the inboard edge of the driving lights was chapped from possible flexing of the lower center fascia. A molded bracket on the lower fascia was not attached to the bumper reinforcement bar. The paint on the top surface of the bumper fascia right of center was peeling from the flexible material. The front bumper energy absorbing devices (EADs) were partially compressed at some point in time and returned to their original positions. The left EAD had compressed 0.25" while the right EAD compressed 0.4" (7/16"). The left driving lamp lens was broken; however, the owners stated that the lens was damaged by a stone approximately one year ago.

Lower Bumper Facia And Driving Light Assemblies.

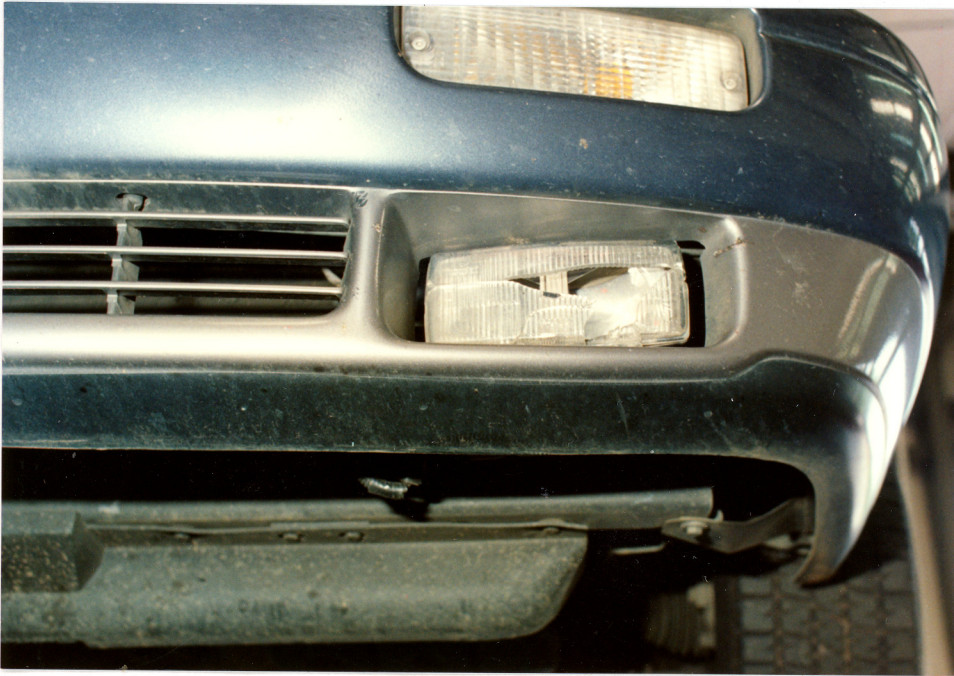
Left Lower Bumper Facia.

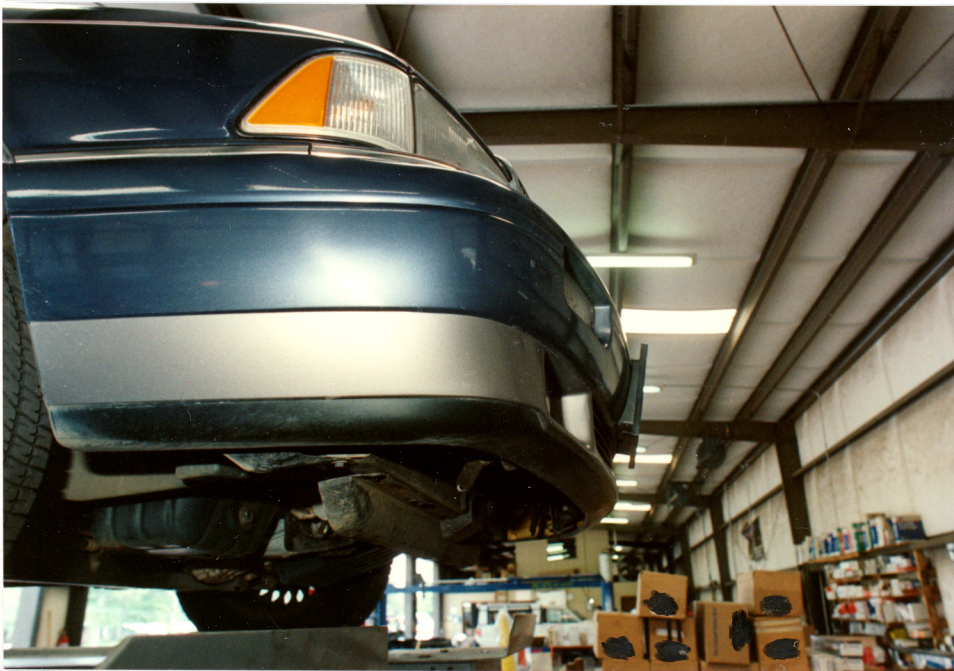
Perpendicular View Across The Right Side Of The Bumper Facia.

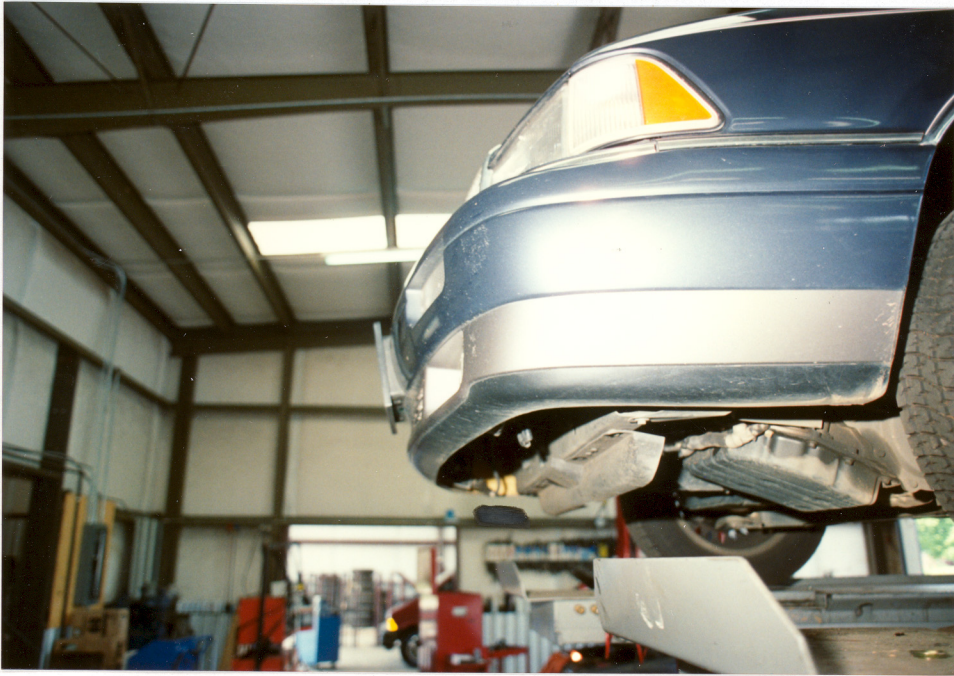
Perpendicular View Across The Left Side Of The Bumper Facia.

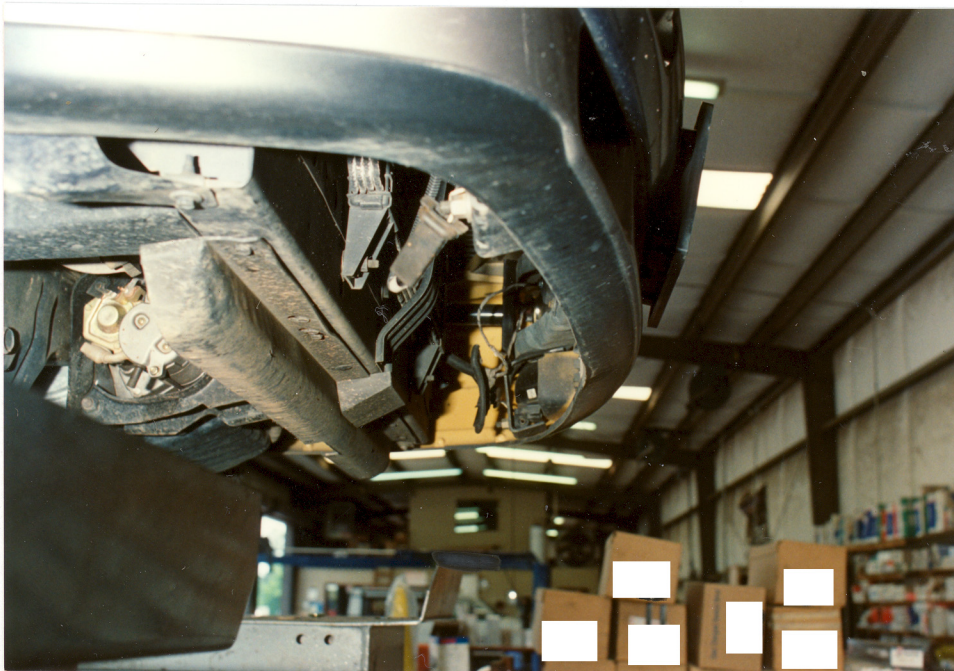
View Across The Facia And Lower Core Support.

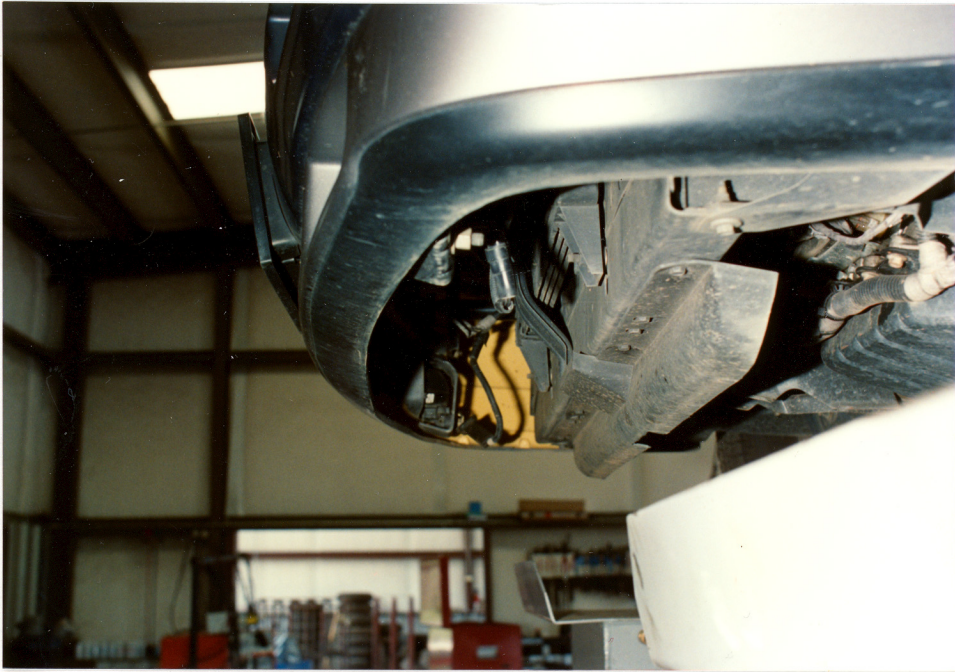
Similar View From The Left Side.

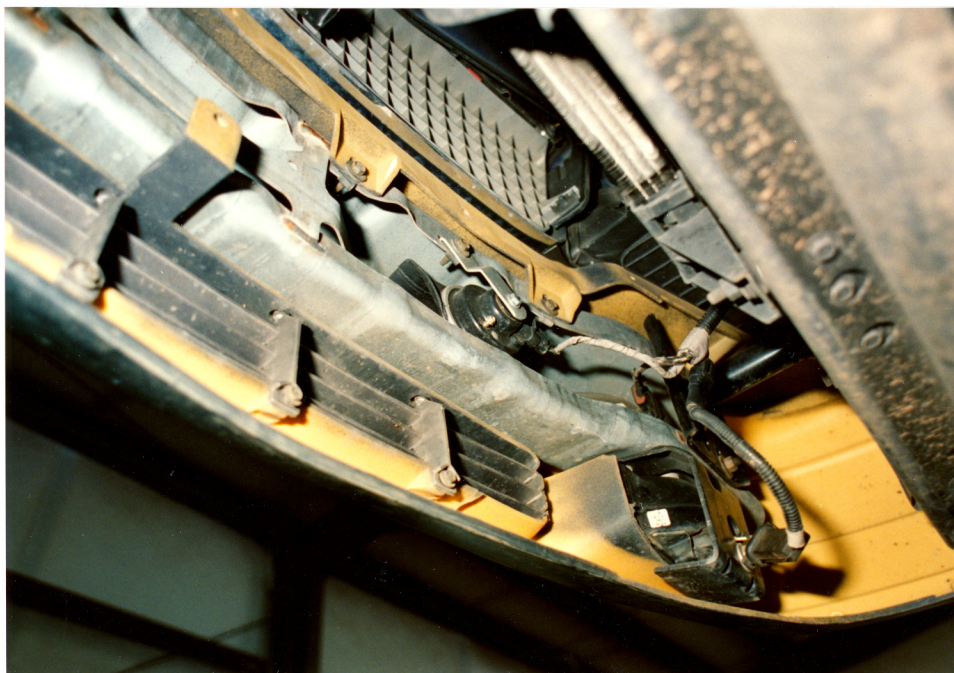
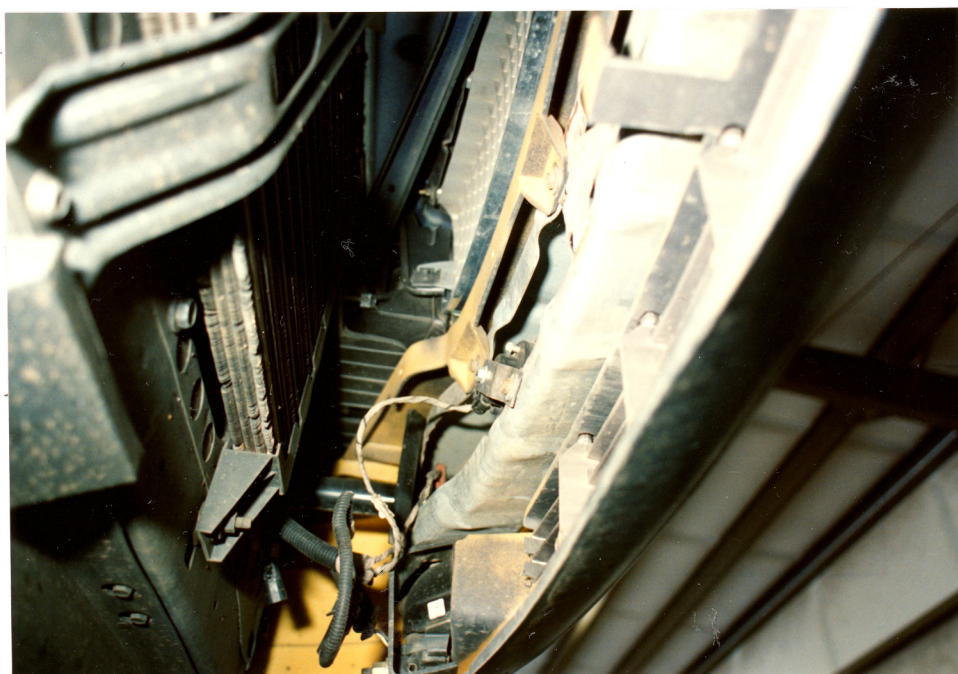
Views Of The Bumper Reinforcement Bar.

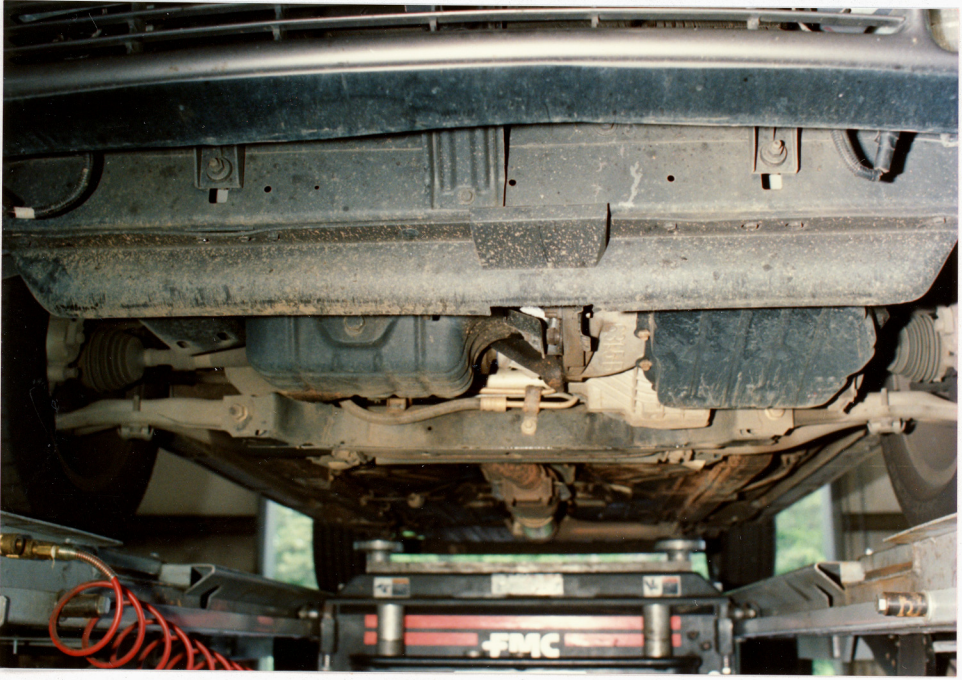
Lower Core Support.

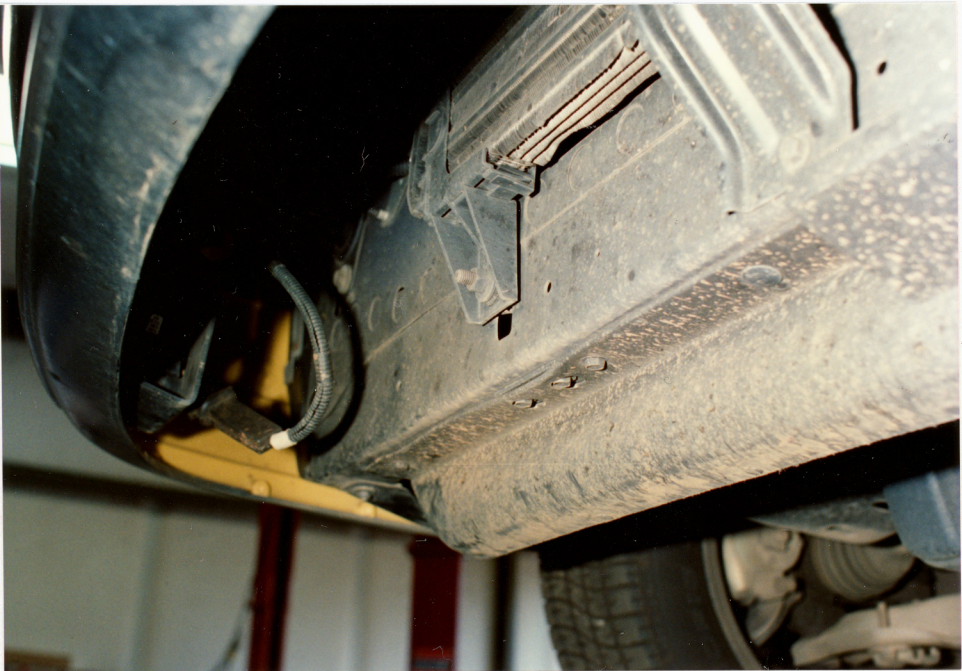
Closeup View Of The Right Side Of The Lower Core Support.

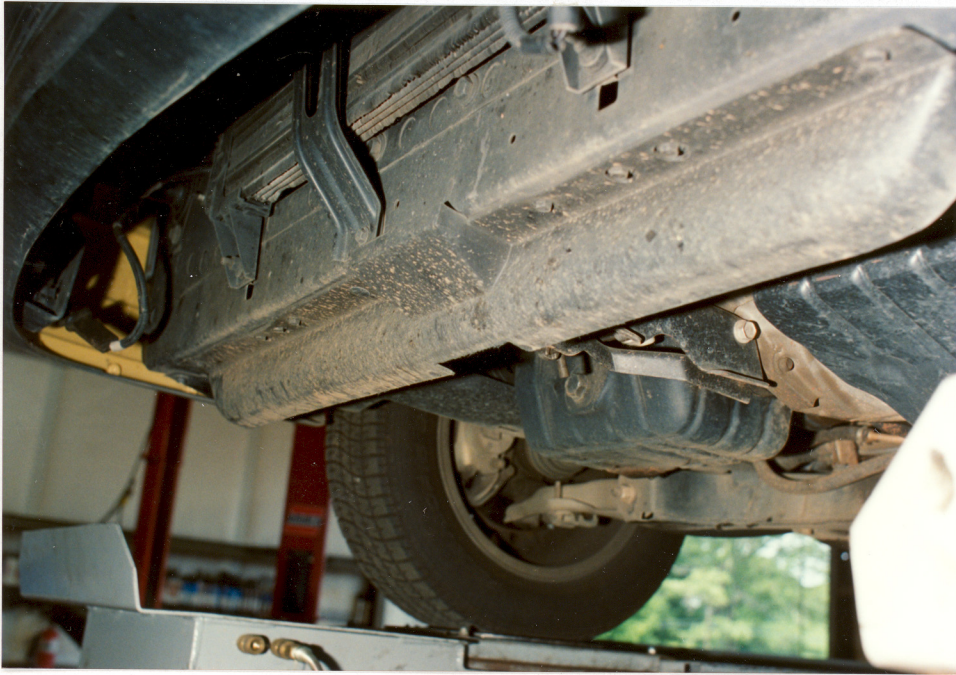
During our inspection of the vehicle, we drove the Plymouth Acclaim to a local service center where they put the vehicle on a lift for a thorough inspection of the undercarriage components. A flexible rubber splash shield was attached to the base of the radiator core support. The shield was not damaged; however, the lower edge of the shield was superficially abraded. The rear edge of the transaxle oil pan was also abraded with no deformation to the pan. Both the splash shield and the transaxle oil pan were probably damaged as the vehicle overrode a curb or a parking curb. The owners did not deny possible contact with a parking curb.

View Of The Splash Shield Attached To The Lower Core Support.

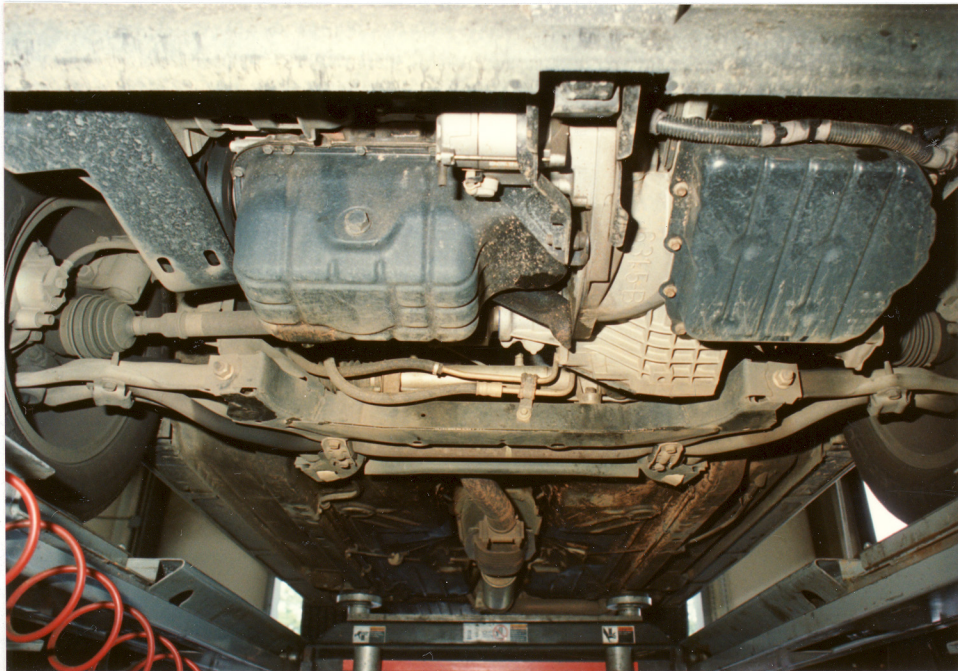
The front crossmember that was located rearward of the engine compartment was not damaged or abraded. A small tissue and hair deposit was noted to the leading edge of the crossmember 8" left of center. The deposits appeared to be fairly recent and probably occurred as the vehicle overrode a small animal. There was no visible damage or displacement of the undercarriage components that would have provided a sufficient longitudinal pulse ($\Delta V \geq 12$ mph) required to deploy the driver air bag system.

Overall View Of The Engine And Transaxle Oil Pans And The Crossmember.

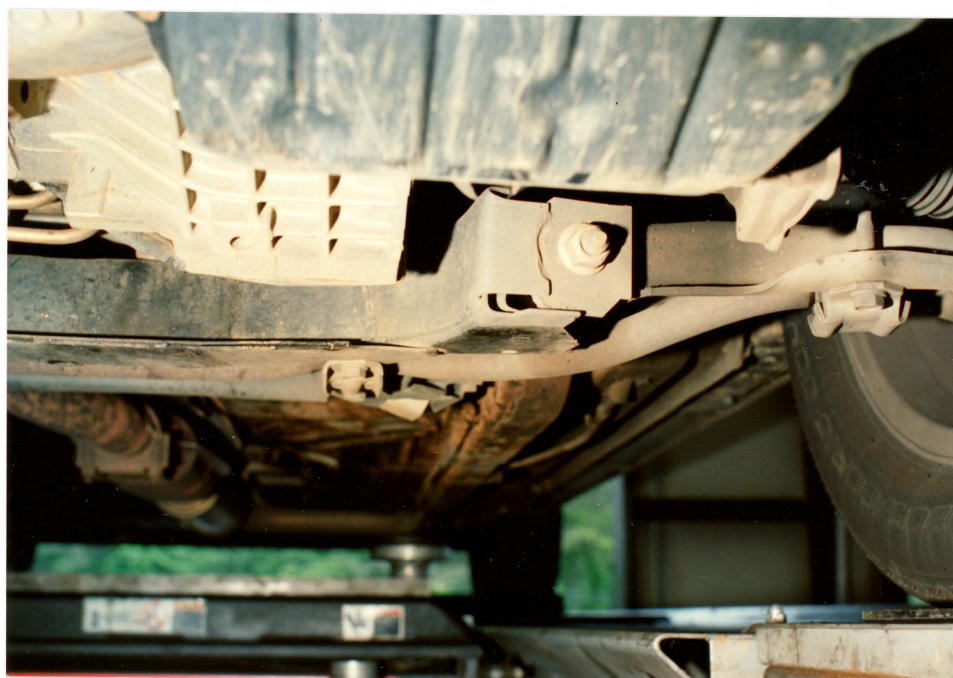
Tissue And Hair
On Crossmember

Left Lower Control Arm.

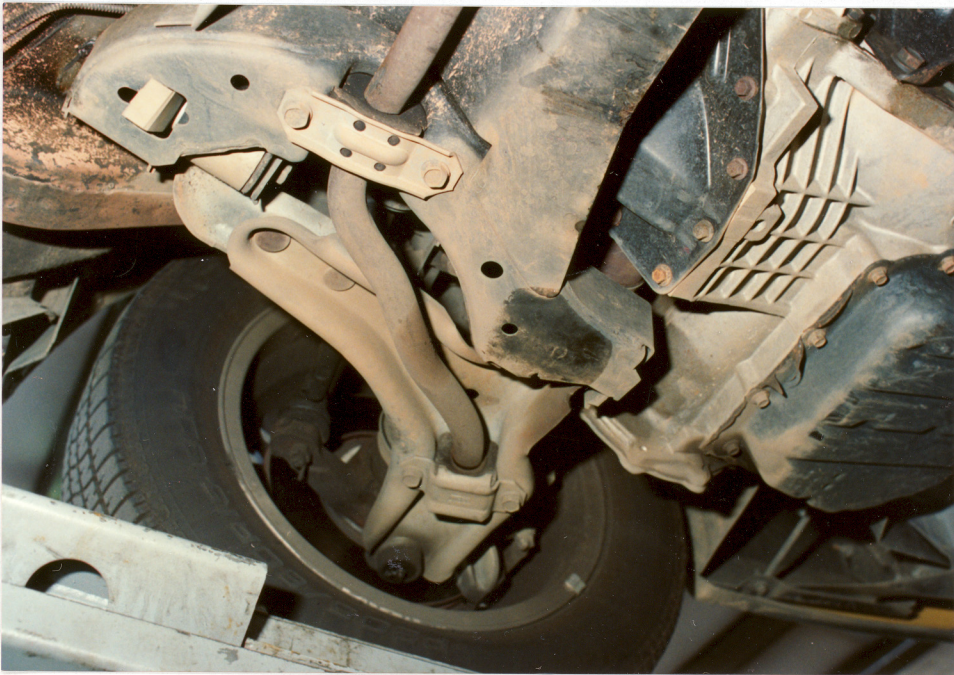
Left Front Drive Axle And Strut.

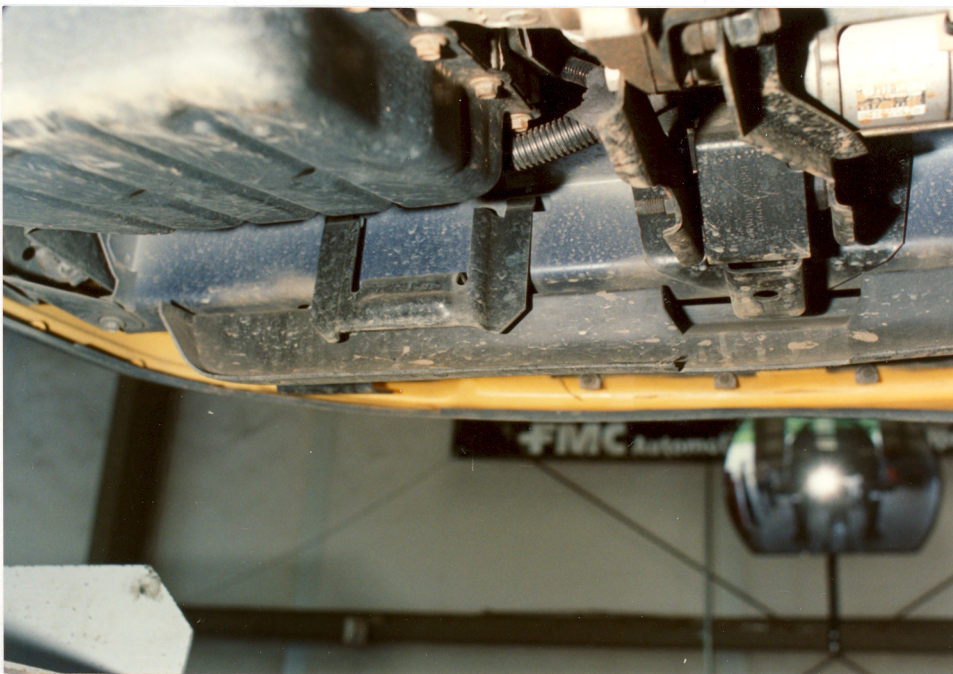
View Looking Forward At The Drive Train And The Lower Core Support.

Forward Views Of The Lower Core Support.
